## Have you ever had pod marks on your material that do not simply wipe off?

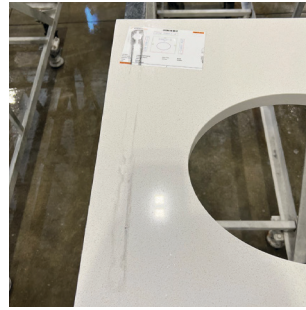
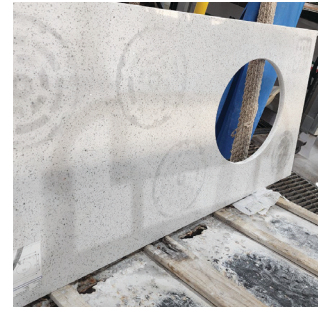
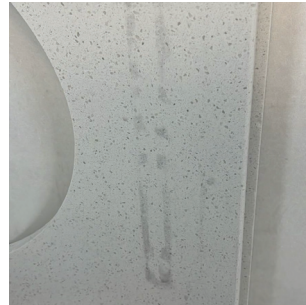
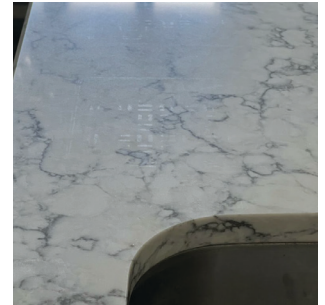
Odds are good that you have a **leak in vacuum**, or not enough vacuum under the material, resulting in an **etching** on the material. A leak or insufficient amount of vacuum can cause **micro-vibrations**. If you combine the micro-vibrations with the **machined particulates** from the material, pulled through the vacuum lines, you can get “**ghosting**” marks.

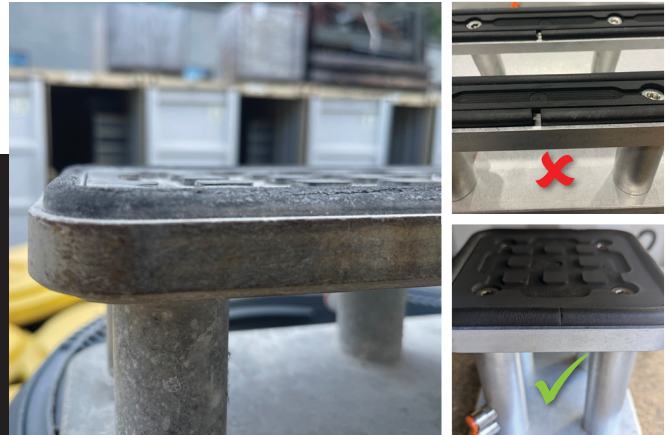
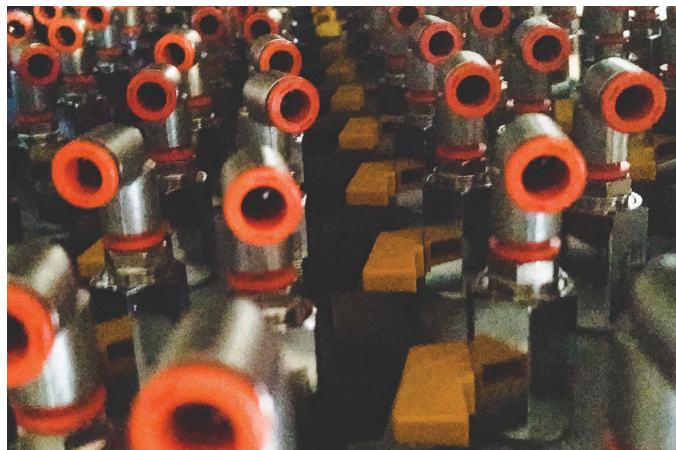
## Check the Top & Bottom Seals:

- The seals should NOT be separated or sitting at a height level with the hard pad or bottom metal plate.
- The seals should NOT be firm to touch.

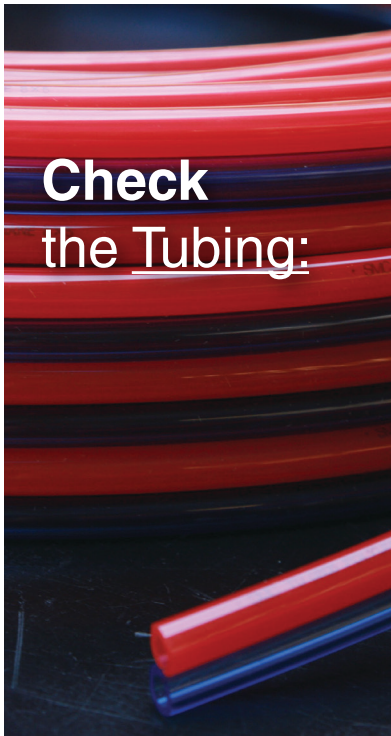
## Check the Fittings & Valves:

- Pod air fittings and manifold combo valves should be clicking in and out.
- If they do not, they need to be changed so there is no vacuum leak.

Ensure  
vacuum lines  
are **soft** at the  
**tip**; where  
they plug into  
the air fitting.

If they  
are firm,  
snip the  
tip off  
square  
and  
plug it  
back in.

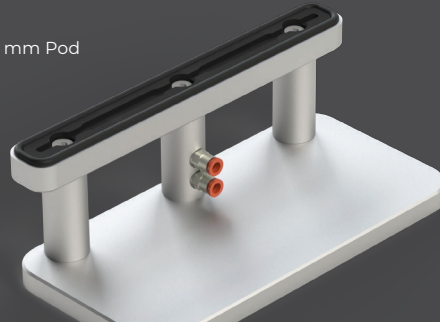
**Ex. 1**  
40 x 150 x 300 mm Pod

If there is only enough material  
and clearance for a narrow rail  
(Ex. 1), you may need to apply a  
Small or Large Edge Clamp (Ex. 2)  
around the pod and material to  
ensure there is no vibrating.

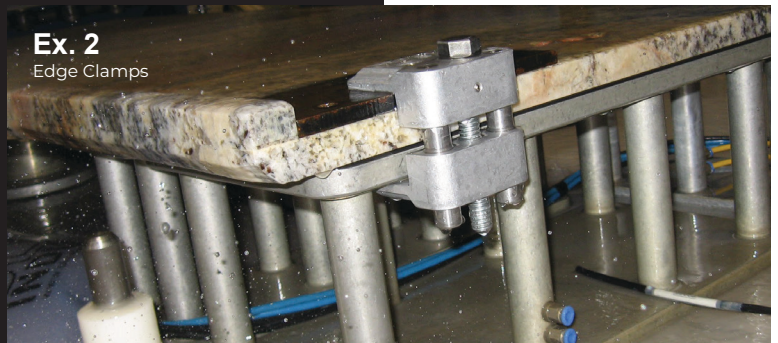
**Ex. 2**  
Edge Clamps

Small Edge Clamp

Large Edge Clamp
